Total Land Subsidence in the Sahuarita and Green Valley Areas, Pima County
Based on Envisat Satellite Interferometric Synthetic Aperture Radar (InSAR) Data
Time Period of Analysis: 1.1 Years 02/23/2007 To 03/14/2008

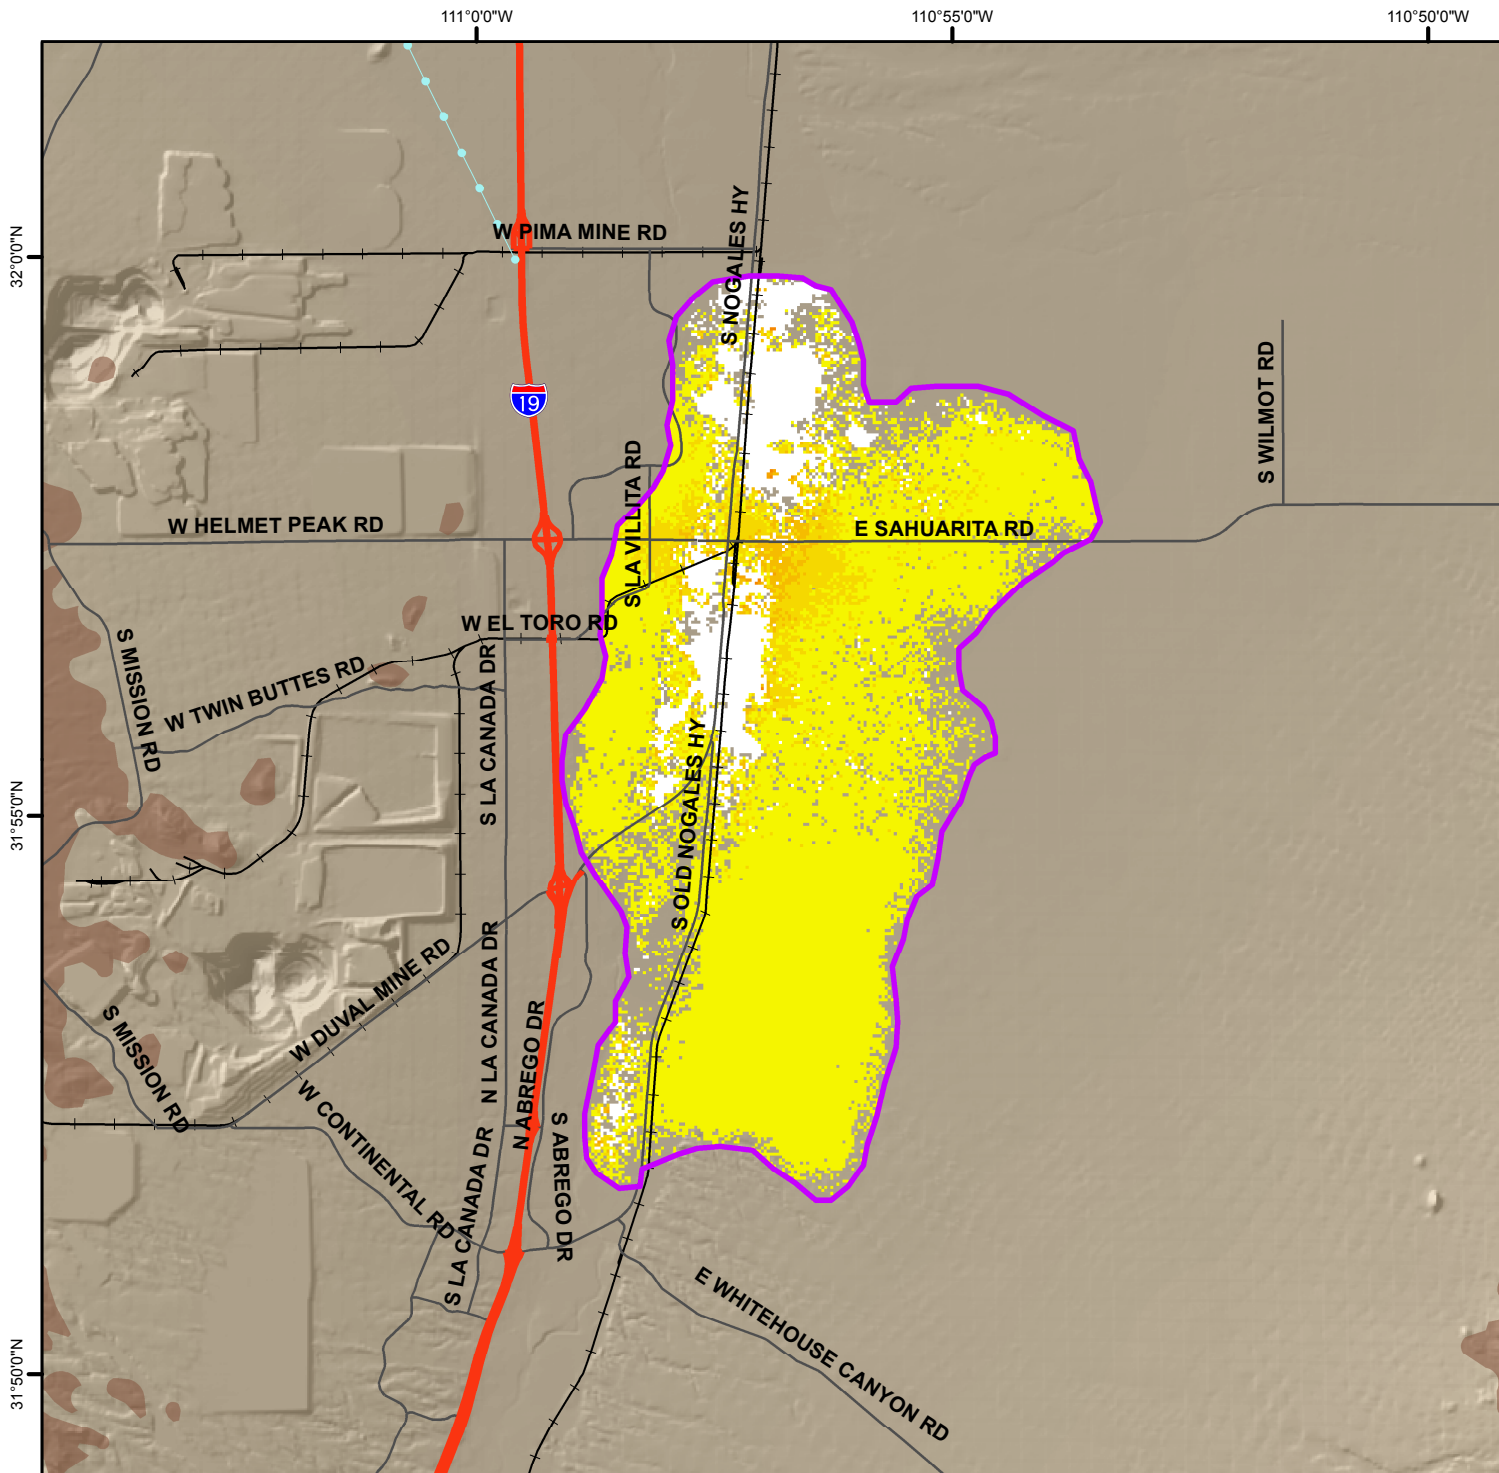
Decorrelation (white areas) are areas where the phase of the received satellite signal changed between satellite passes, causing the data to be unusable. This occurs in areas where the land surface has been disturbed (i.e. bodies of water, snow, agriculture areas, areas of development, etc).
